GUNITE Service Bulletin

Cleaning of Hub Pilot

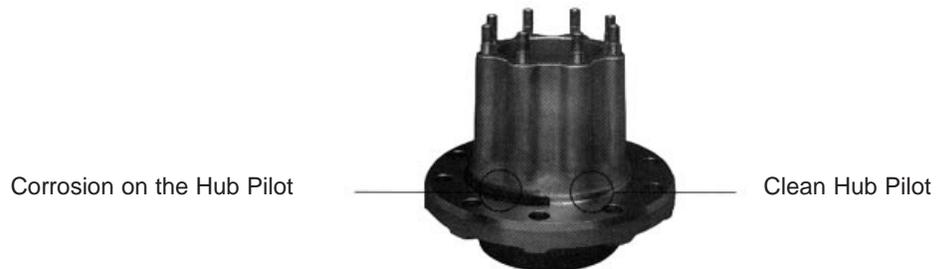
This bulletin is to inform you of field problems which result in cracked drums at the mounting flange, due to improper cleaning of the hub pilot.

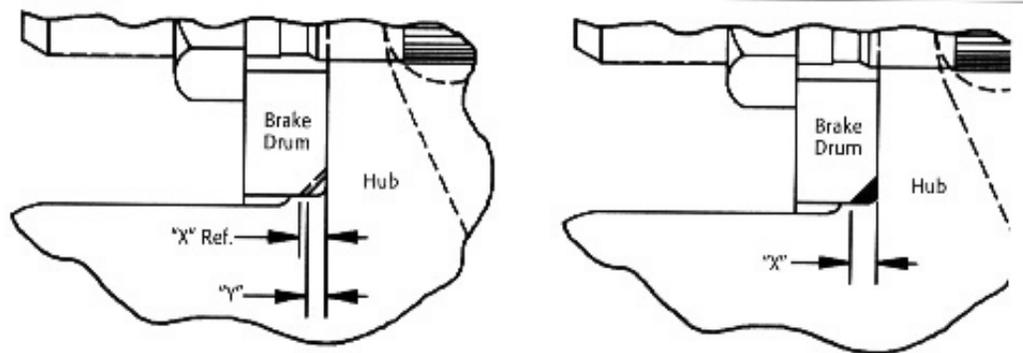
Drum manufacturers machine different pilot chamfers where the drum mates to the hub. If corrosion builds up behind the chamfer ("X") and a drum with a smaller chamfer ("Y") is installed without cleaning the corrosion from the hub, the drum mounting flange can break when the assembly is torqued. Use a scraper to clean corrosion from the hub before installing a new drum.
