Gunite Hub Installation

GUNITE Service Bulletin

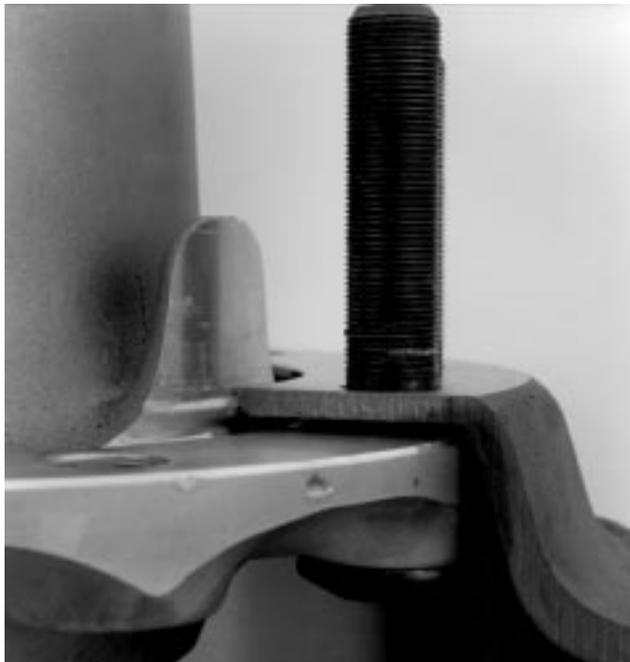
Figure 1
Drum cocked and not seated properly on the drum pilot of the hub.

The brake drum, shown above in figure 1, is not properly seated on the drum pilot of the aluminum hub. If the brake drum is improperly installed as shown, and allowed to rest on the wheel pilot and not the drum pilot, the drum will shave the drum pilot when the wheel assembly is torqued down. If the brake drum is cocked during installation and not allowed to seat flat against the hub flange, the brake lining may drag against the drum causing drum failure.

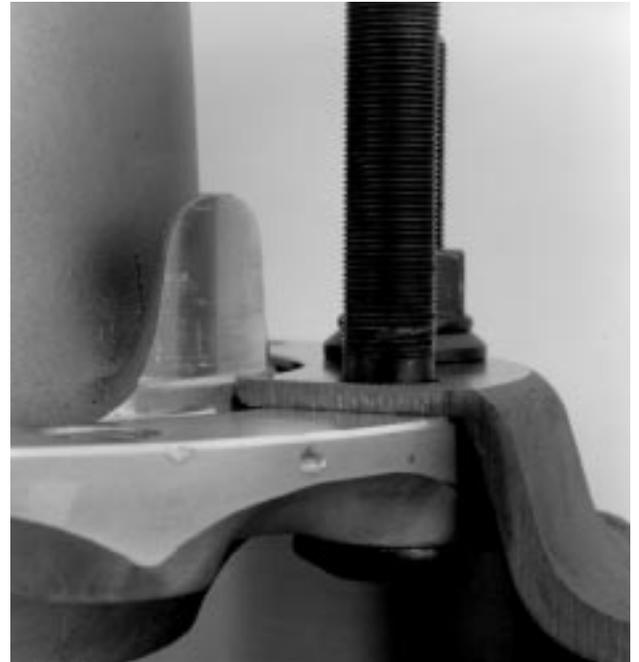
Figure 2
Correctly installed drum properly positioned on the drum pilot of the hub.

When the brake drum is installed properly, as shown in figure 2, the drum is seated up on the drum pilot of the hub and rests flat against the hub flange.

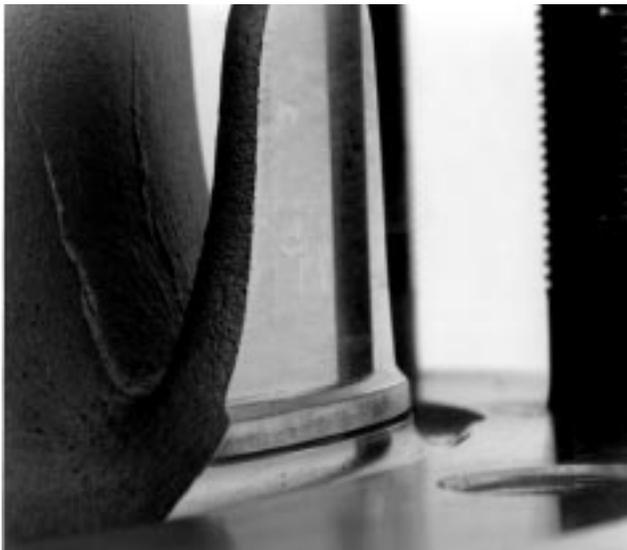
Figure 3 *Shaved drum pilot.*

The drum pilot on the hub shown in figure 3 has been damaged as a result of the drum not being properly installed on the drum pilot and being allowed to rest on the wheel pilot instead. If the drum is installed in this manner, the drum will be cocked and will damage or shave away the surface of the drum pilot when the wheels are installed.

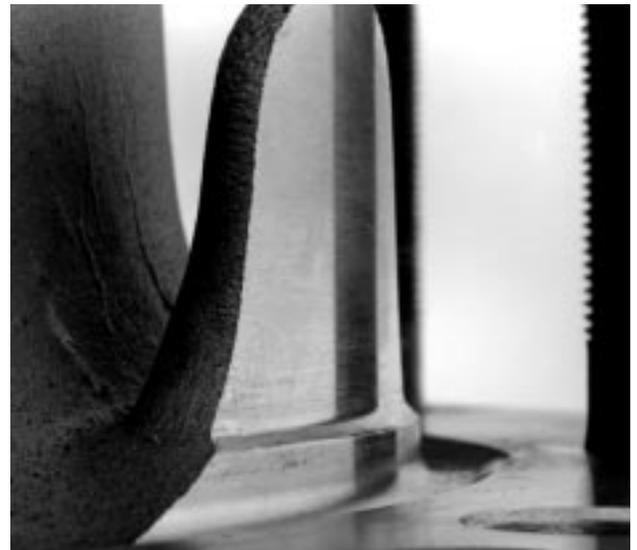
Figure 4 *Undamaged drum pilot.*

The drum pilot on the hub shown in figure 4 has not been damaged because the drum was properly seated on the drum pilot and was not allowed to rest on the wheel pilot. This allowed the wheels to be properly mounted on the wheel pilot and the assembly to be tightened without damage to the drum pilot.

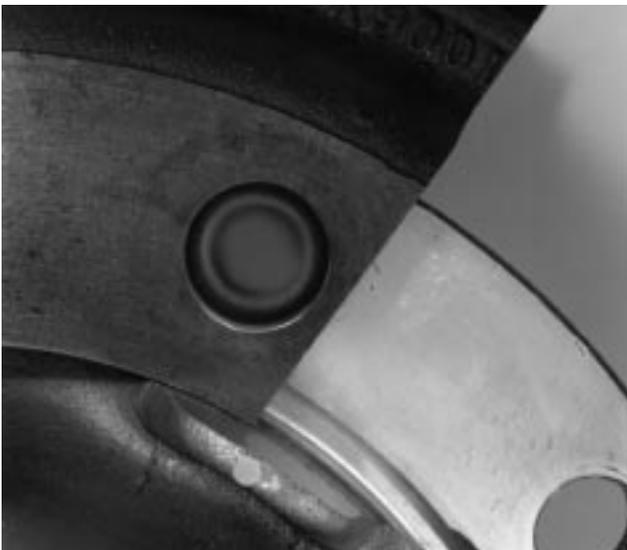
Figure 5 *Gunitite-Lite drum with 1" mounting holes should not be used on an aluminum hub.*

Gunitite-Lite brake drums with 1" mounting holes should not be used with aluminum hubs because the larger holes can allow the drum to be improperly positioned during installation. This potential misalignment could result in the drum resting on the wheel pilot instead of the drum pilot as shown in figure 5. Gunitite-Lite brake drums with 1" mounting holes are to be used with steel or ductile iron hubs only.

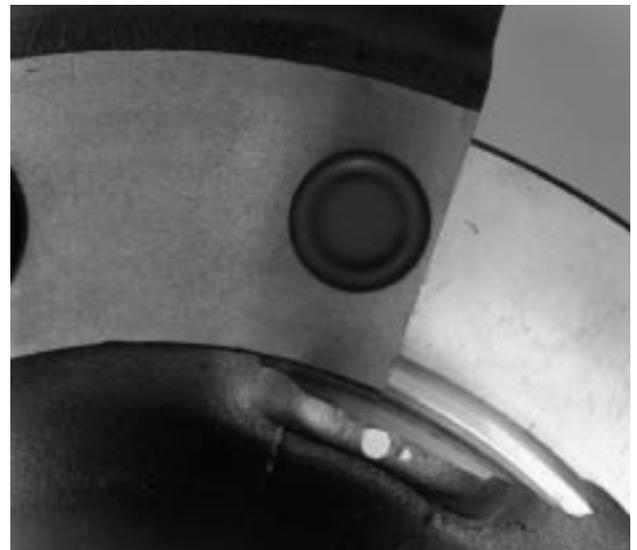
Figure 6 *Gunitite-Lite drum with .91" mounting hole for use with aluminum hub.*

The new Gunitite-Lite brake drums are manufactured with .91" mounting holes to help center the drum and keep it off of the wheel pilot during installation. Because of the smaller mounting hole, the new Gunitite-Lite brake drums provide better alignment with the drum pilot resulting in less chance of the drum being cocked during wheel installation and less potential for damage to the drum pilot on the aluminum hub.

WARNING: Gunitite-Lite brake drums with .91" mounting holes are for use with aluminum hubs only. These brake drums should NOT be used with steel or ductile iron hubs. Use of the Gunitite-Lite brake drum with the .91" hole on a steel or ductile iron hub may cause interference between the mounting hole and the wheel bolt during installation.
